## CHAPTER 7

### PROBLEMS OF CAPSIZING WITH SPECIAL REFERENCE TO THE TOYA MARU DISASTER [71]

#### 7.1 Introduction

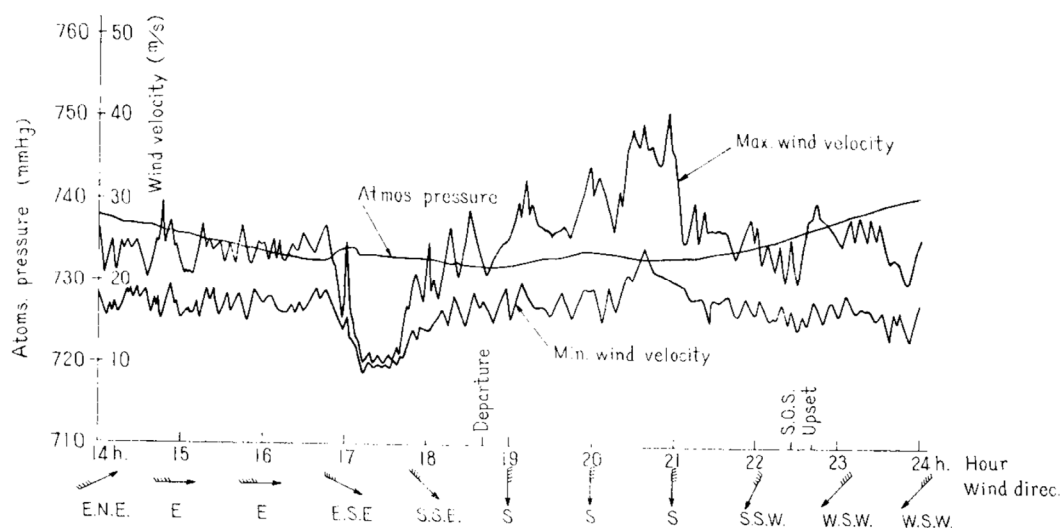
FIG. 7.4 WIND VELOCITY, WIND DIRECTION AND ATMOSPHERIC PRESSURE

Fig. 7.4 illustrates the atmospheric pressure and wind velocity observed by the Hakodate Oceanic Weather Bureau. Wind velocity here is

the average value over ten minutes, so that the maximum instantaneous velocity should be considerably greater.

As already mentioned, the typhoon centre swept westward over Hakodate, the atmospheric pressure showed the minimum value from 16 to 18 h. and the wind lulled. This fact obviously indicates the passage of the typhoon centre. Ironically enough, Toya Maru departed the pier at 18.40 h. when the typhoon centre was passing through the Hakodate.

With the passage of the typhoon centre the wind blew back after 18 h. and its direction changed to south and then to southwest. The south-west wind continued its blowing due to the stagnation of the typhoon centre. Consequently Hakodate was faced with grown-up waves.

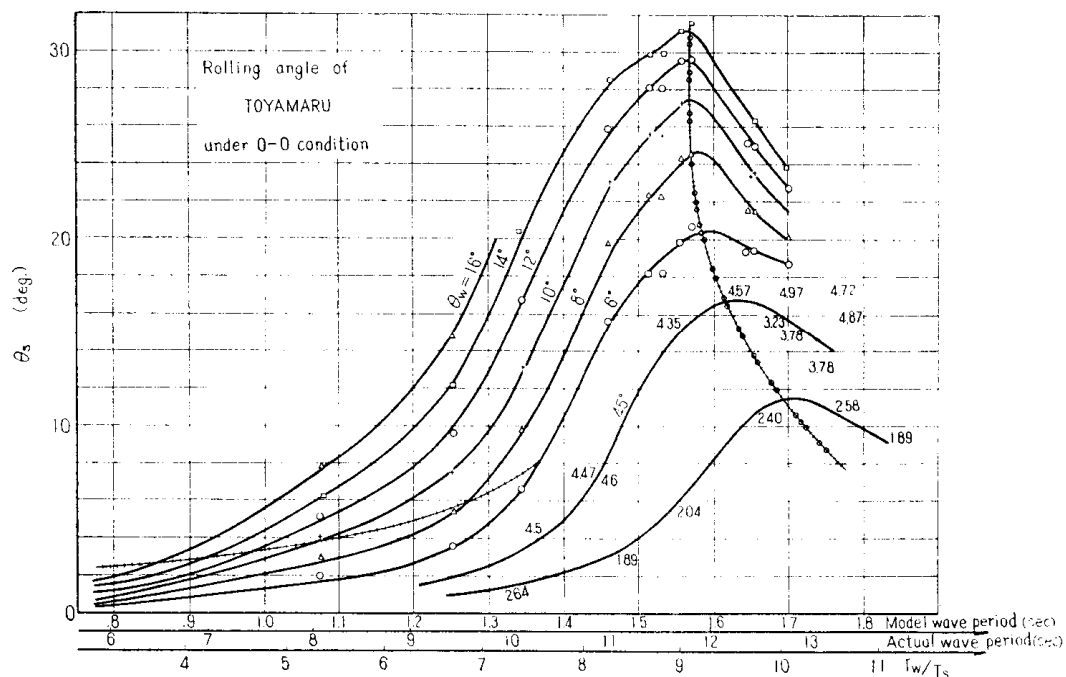
The rolling angle of Toya-maru under the intact condition, and the flooded conditions are shown in Figs. 7.25 and 7.26 respectively, and the rolling angle of Tokachi-maru under the flooded conditions are shown in Figs. 7.27 and 7.28 respectively.

FIG. 7.25 ROLLING ANGLE OF TOYA MARU UNDER 0~0 CONDITION

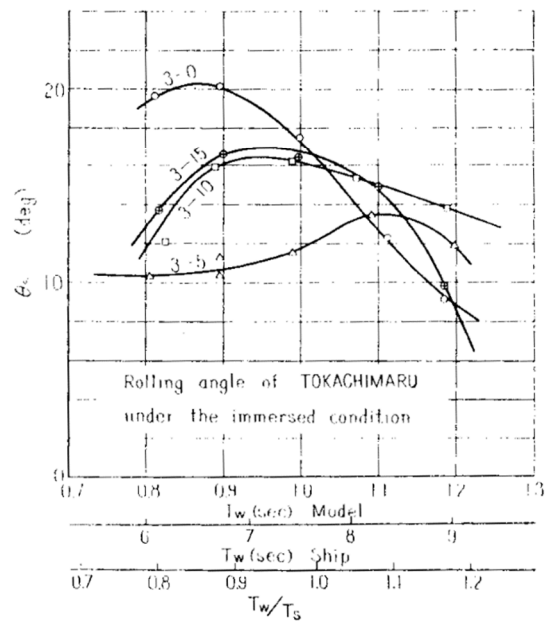
FIG. 7.28 ROLLING ANGLE OF TOKACHI MARU UNDER THE IMMERSED CONDITION
